STATE OF WASHINGTON
DEPARTMENT OF ECOLOGY

Project: Lake Sawyer Outlet Structure
File Number: KI09-1177

Subject: June 28, 2011 At-Public-Request Inspection

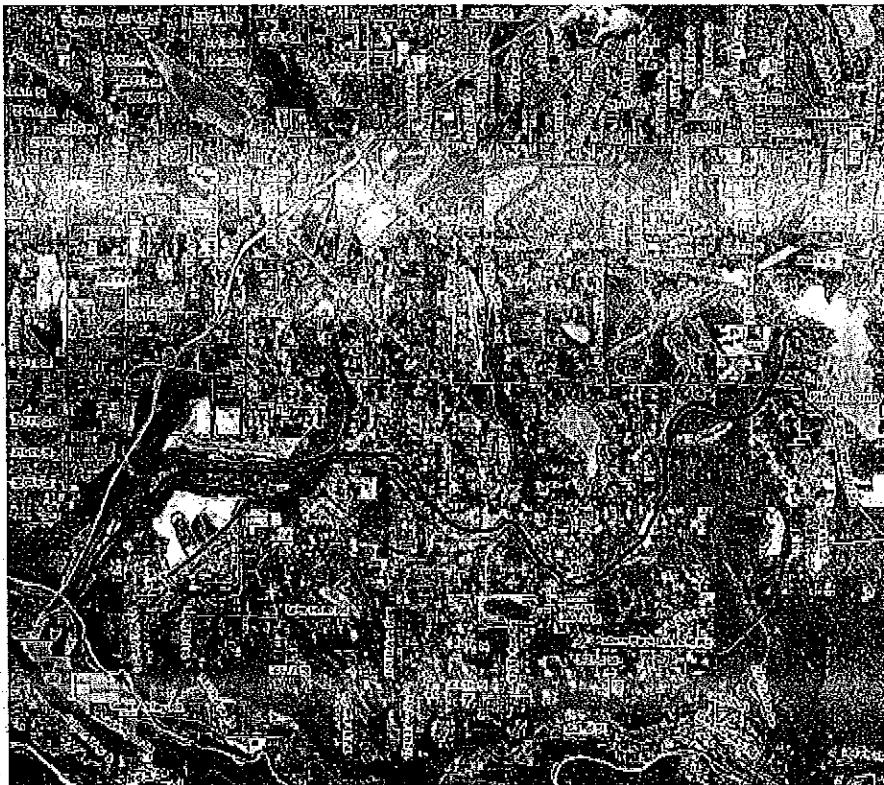
Lake Sawyer Outlet Structure Inundation Map

The downstream hazard area is principally wooded streambed. The general area is semi-rural mostly developed into large lot residential homes of several acres each. There are two main roadway crossings between the dam and where Covington Creek enters the Green River about 15 miles downstream. See the attached Inundation Map.

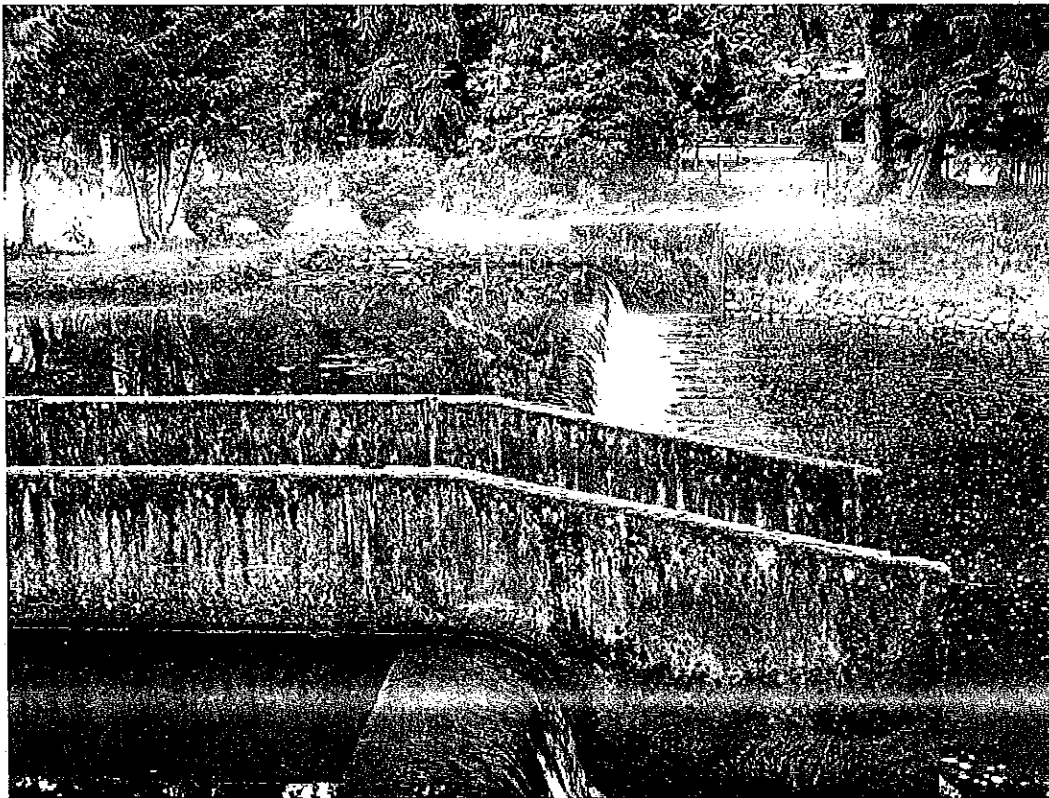
Fish Passage and Crest from Right Abutment

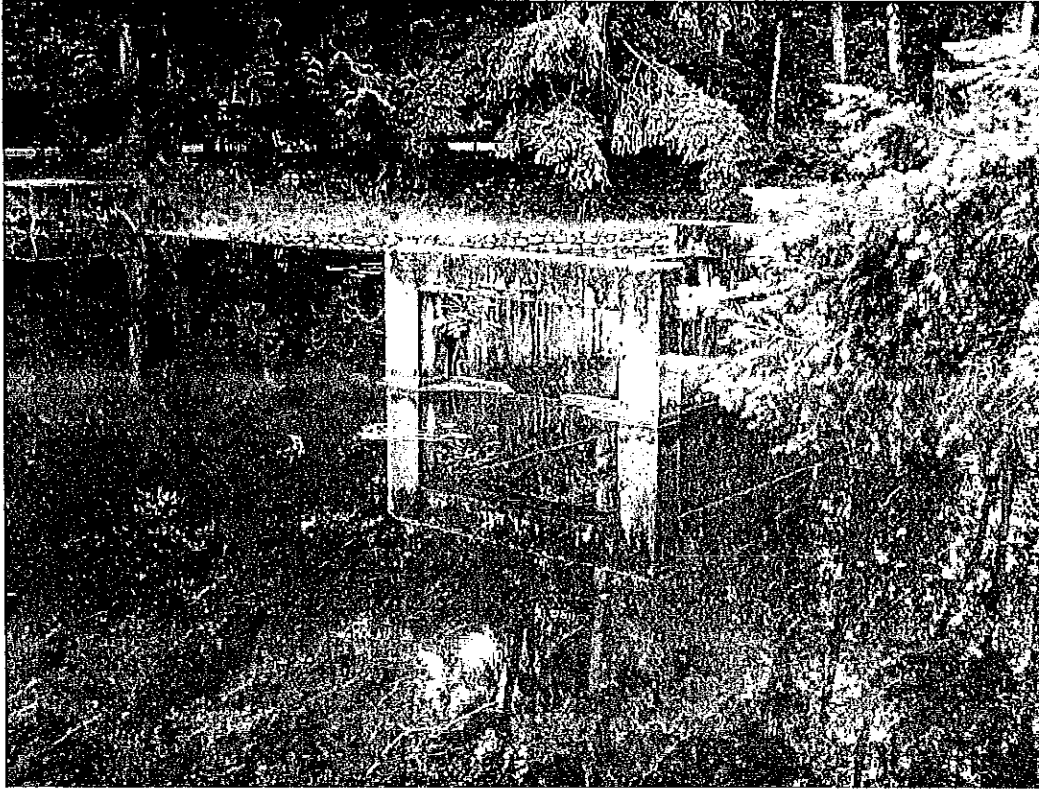
Fish Passage Entrance

Debris: Since there is no log boom or other device to limit debris from impinging on the structure, quarterly maintenance should identify any need for debris removal. The owners should then make arrangements for debris removal. The entry to the fish passage may be particularly susceptible to debris build up and should be observed specifically each quarter so debris is eliminated in order to keep fish passage functional.

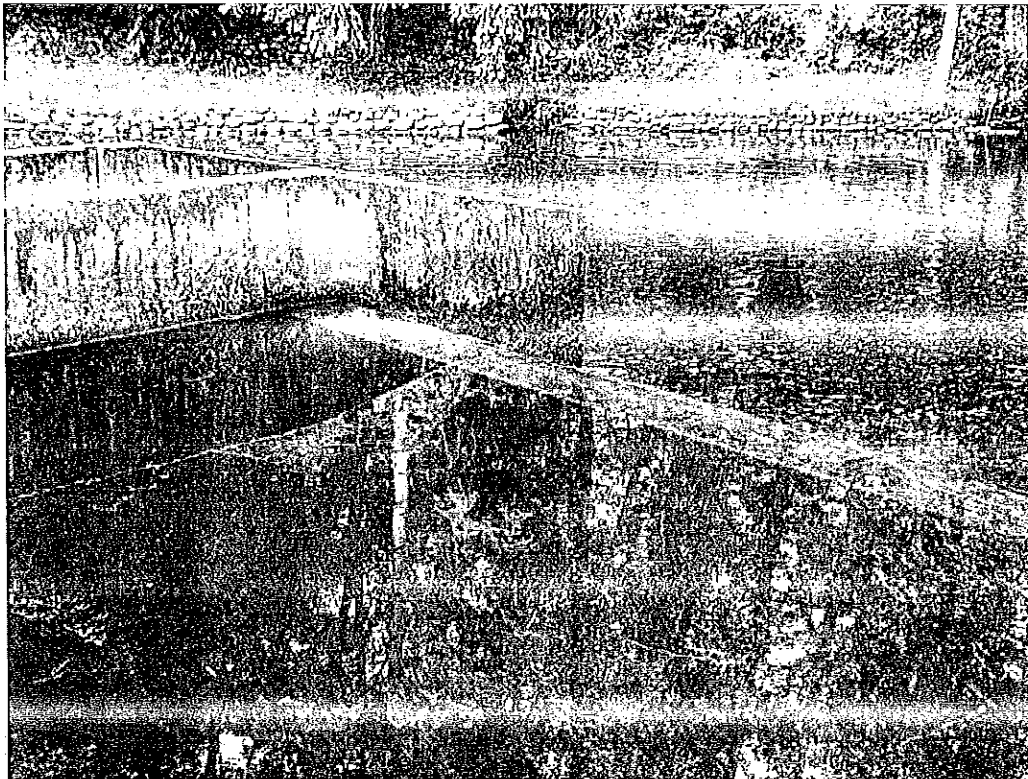
Right Side Dam Crest Looking Downstream

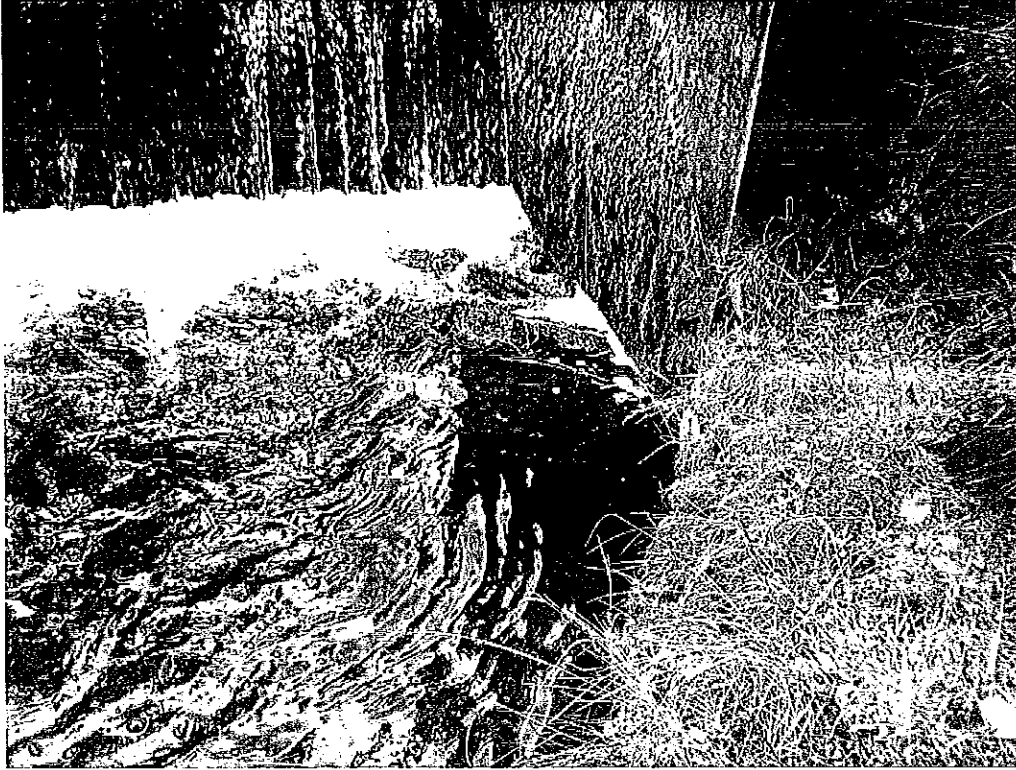
appeared to be stable. There is a large stump on the right toe near the abutment. It appeared to be stable. No scour holes were observed.

Stump Remnant at Left Downstream Toe

the left abutment, there is a large stump that was cut off at the water line at some time in the past. This area should be observed for potential changes or deterioration of the apron and abutment in the area.

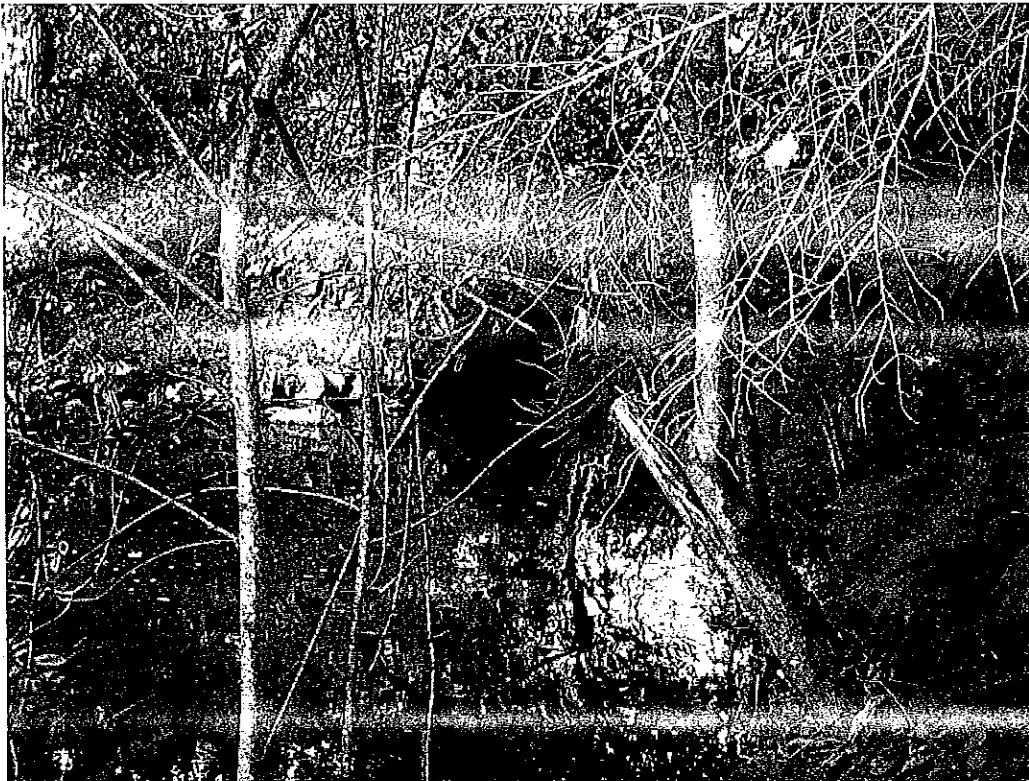
The inspection included reviewing the flow pathway of a potential dam breach flood from the dam until Covington Creek enters the Green River. The first road crossing was at 224th Street less than 100 feet downstream of the dam. There were 3 large approximately 5 feet diameter corrugated metal pipe (CMP) culverts that pass the Covington Creek flow at that point. The culverts were flowing about ¼ full at the time of the inspection. The roadway is approximately 3 to 4 feet above the dam elevation and would constrict the potential dam breach flow rate, if the dam were to fail.

224th Street Culvert Looking from Right Abutment

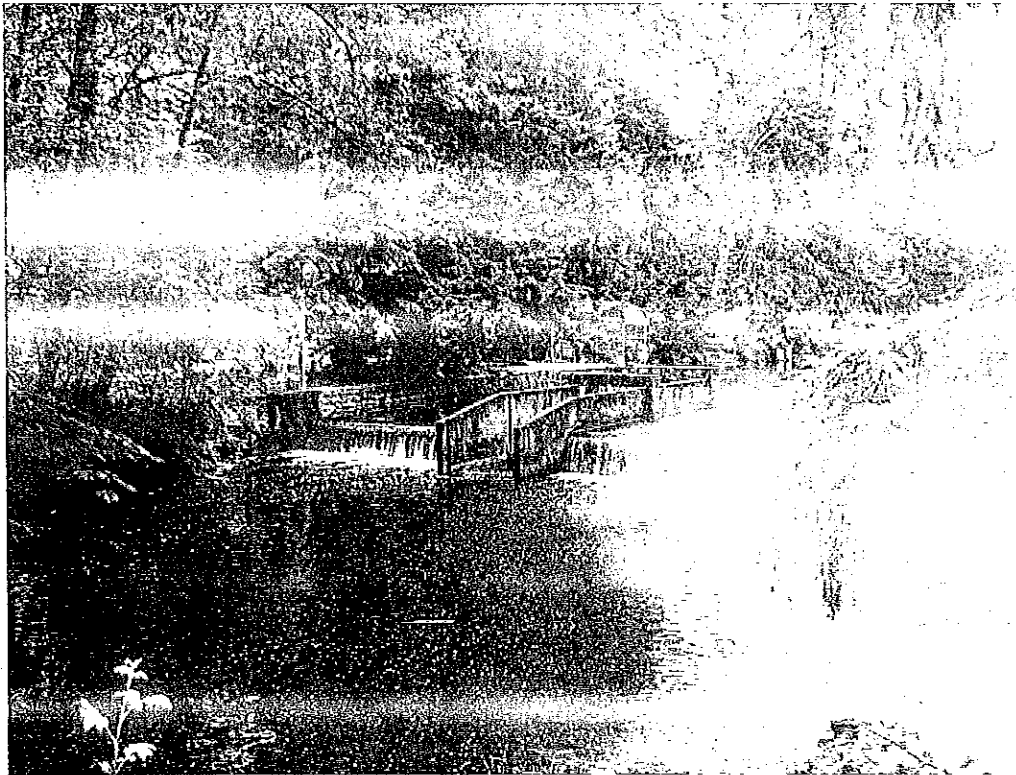
Looking Upstream at Dam from 224th Street Roadway Margin

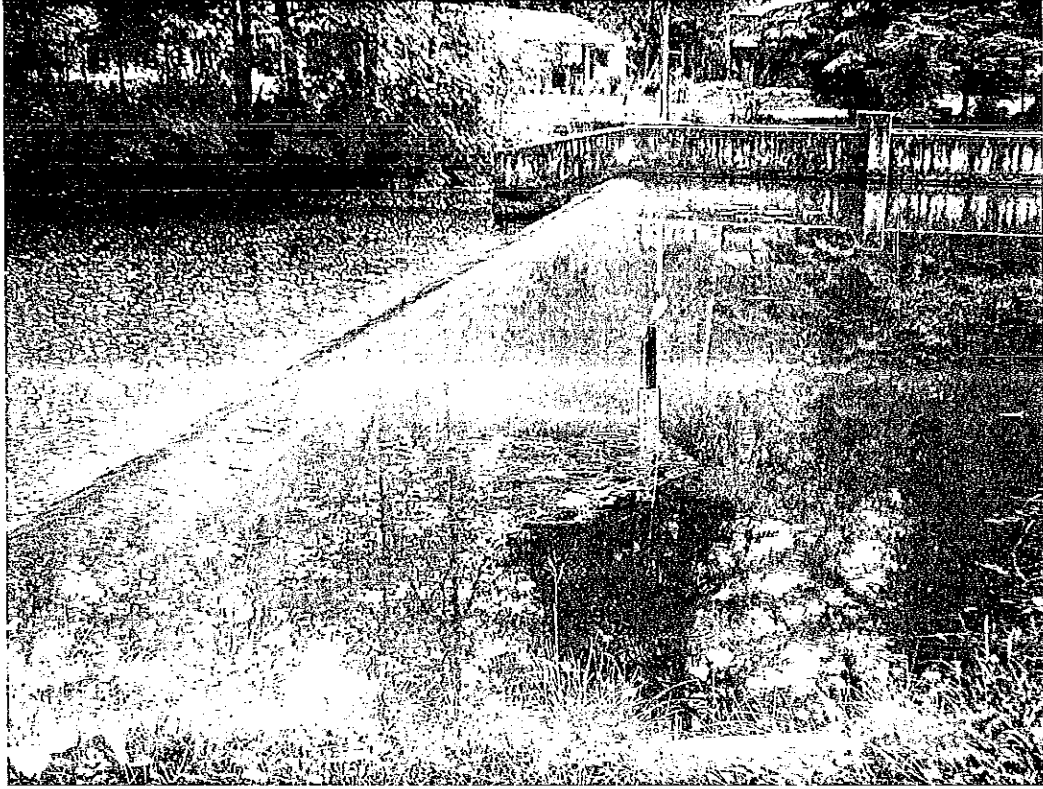
Water Level Indicator Looking from Left Abutment

Water level measurements should be made quarterly (around January 1, April 1, July 1 and October 1) by the owners and recorded in a log book. The only instrumentation at the dam is the water level gage (indicator). This gage measures the upstream water level and is most easily observed from the left abutment area. Measurements can be correlated to stream flow rate for Covington Creek using the water level, dam width dimensions and standard weir flow rate calculation methods. These measurements may be useful by city or county officials, or others, to monitor stream flow for fish or flood protection purposes. Use the chart below to convert water level measurements to approximate stream flow rates.
