STATE OF WASHINGTON
DEPARTMENT OF ECOLOGY

Project: Lake Sawyer Outlet Structure
File Number: KI09-1177

Subject: June 28, 2011 At-Public-Request Inspection

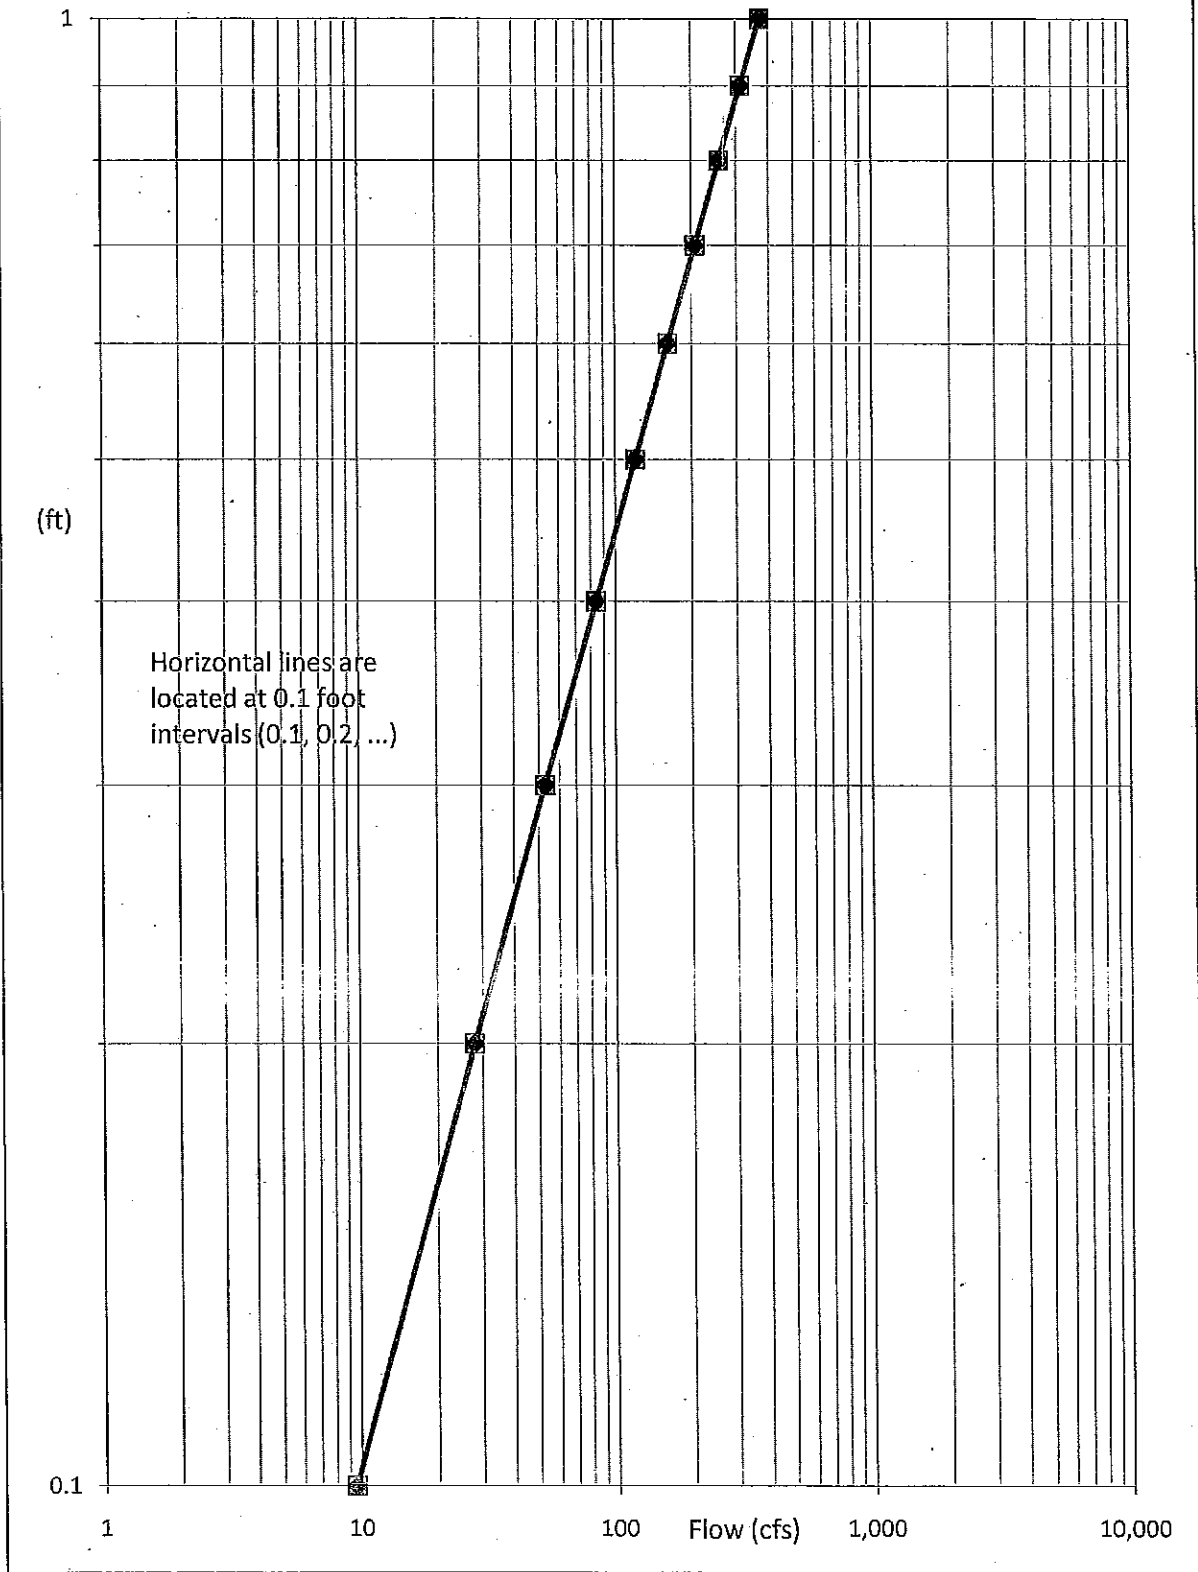
Flow (cfs) versus Head (ft)

Water level measurements should be made quarterly (around January 1, April 1, July 1 and October 1) by the owners and recorded in a log book. The only instrumentation at the dam is the water level gage (indicator). This gage measures the upstream water level and is most easily observed from the left abutment area. Measurements can be correlated to stream flow rate for Covington Creek using the water level, dam width dimensions and standard weir flow rate calculation methods. These measurements may be useful by city or county officials, or others, to monitor stream flow for fish or flood protection purposes. Use the chart below to convert water level measurements to approximate stream flow rates.
